⑥ National Dam Inspection Program. Dehart Dam (Inventory Number NDS-PA-561), Susquehanna River Basin, Clarks Creek, Dauphin County, Pennsylvania. Phase I, Inspection Report.

DEHART DAM

INVENTORY NUMBER NDS PA-561

PHASE I INSPECTION REPORT

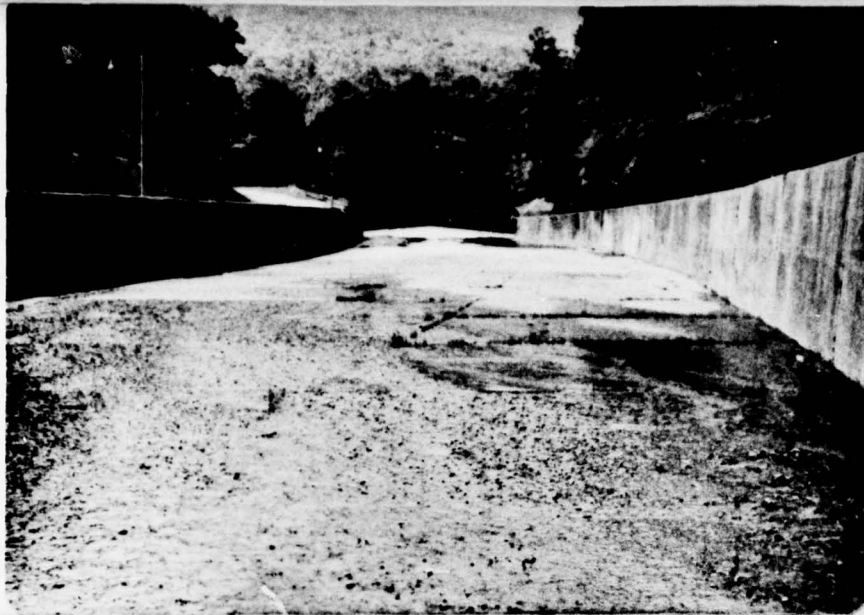
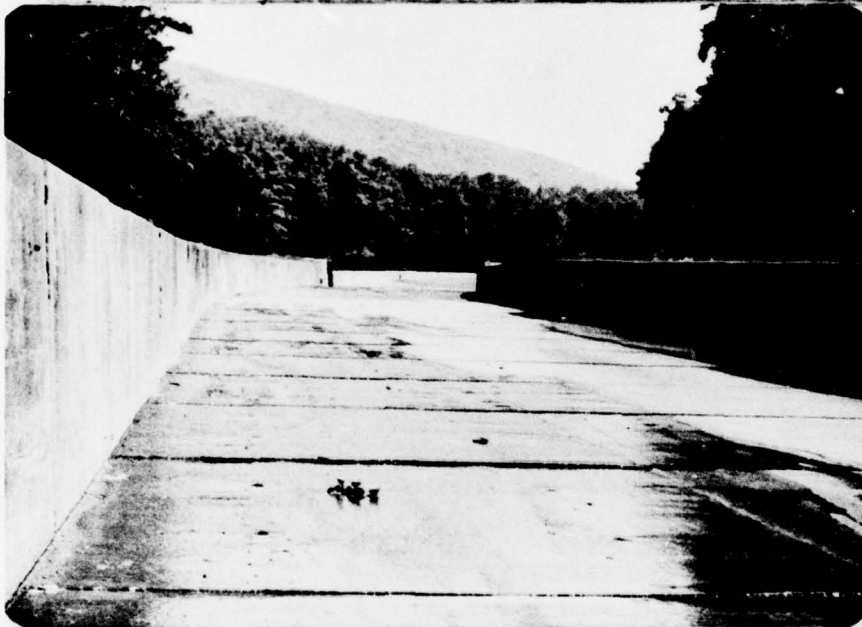
With the exception of some surface weathering on several slabs and exposed joints, the slabs of the spillway channel are in good condition. The walls are also in good condition. Some heavy spalling was observed at the top of some of the wall sections at the construction joint. These conditions do not impair the function of the spillway but preventative maintenance should be encouraged.

New slabs placed as a result of the 1972 tropical storm Agnes were observed to be in excellent condition. Weep holes were placed in these new slabs.

C. DISCHARGE CHANNEL Lining Cracks Spilling Basin	Spalling on wall at end of sloped section on left side at top plus several others along the entire channel. Slabs in good condition. Curbed, superelevated channel Cracks in top of right spillway sloping wall.

1. Observe and record the behavior of the apparent seepage at the toe of the embankment left of the left spillway wall. Take appropriate remedial measures if indicated.
2. Repair the spillway walls and slab of the spillway outlet channel as soon as possible.
